Honokowai Water Quality Management Plan

June 2016

Prepared for:
NOAA Coral Reef Conservation Program

Prepared by:
Horsley Witten Group, Inc.

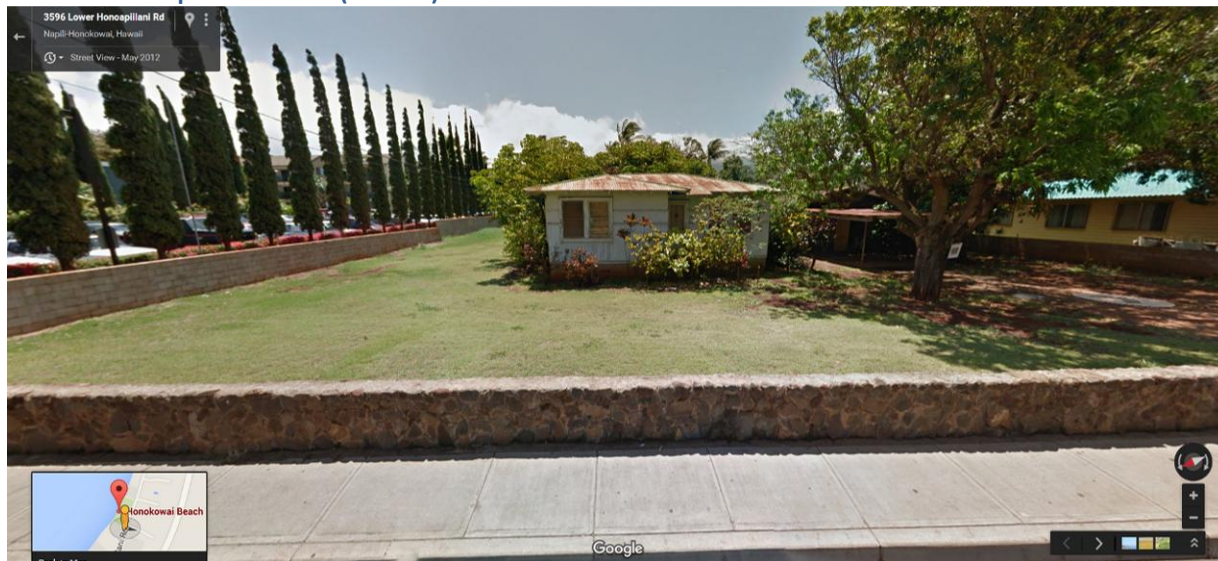
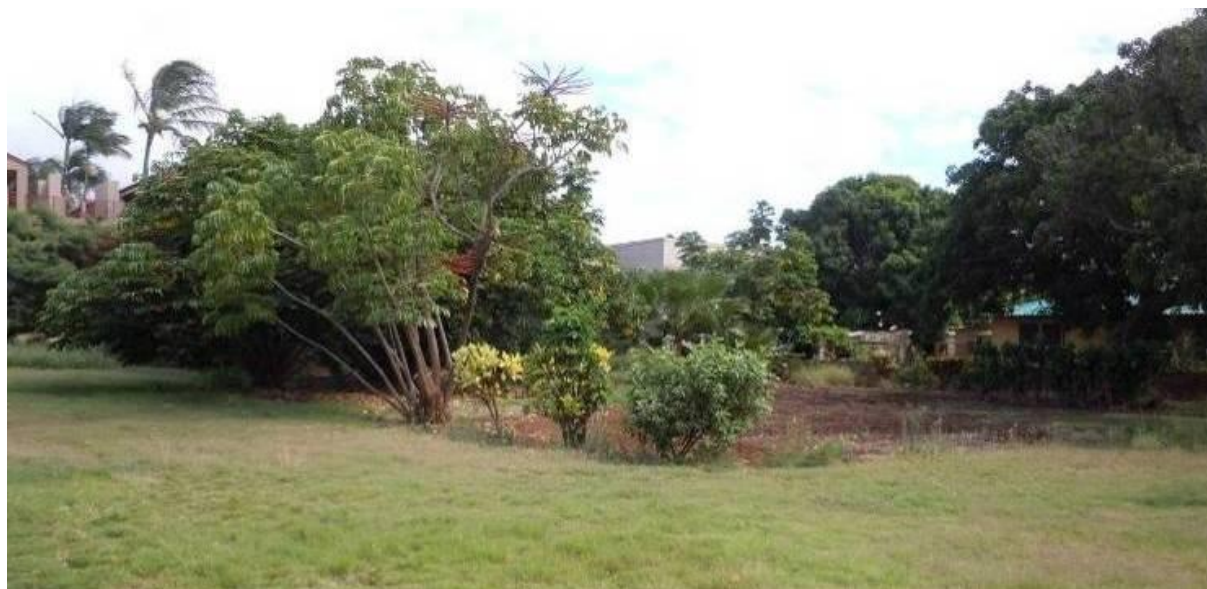
R-4: Vacant Land – Constructed Wetland

The residential property at 3614 Lower Honoapiilani Rd used to have a single-family house on it; however, the land is currently vacant. If this property could be purchased for stormwater purposes, it could provide vital space needed in this highly impervious watershed. It is in an ideal location, near the lowest point in the watershed, to provide stormwater management for surrounding properties. For purposes of this analysis, we assumed that only stormwater diverted from the Sunset Terrace drainage network would be directed into this property; however, it is possible that runoff from the storage unit/commercial lot could also be directed here. A constructed wetland is proposed here given the site's low elevation, and thus, assumed high groundwater, as well as the large drainage area (5.5 acres, 95% impervious). This site could also be designed as a park with boardwalks and sitting areas, to help relieve some of the pressure on HBP as well as provide additional educational opportunities.

Screenshot from Google StreetView, showing former residence (top); photograph of the same property during field work in September 2014 (bottom).

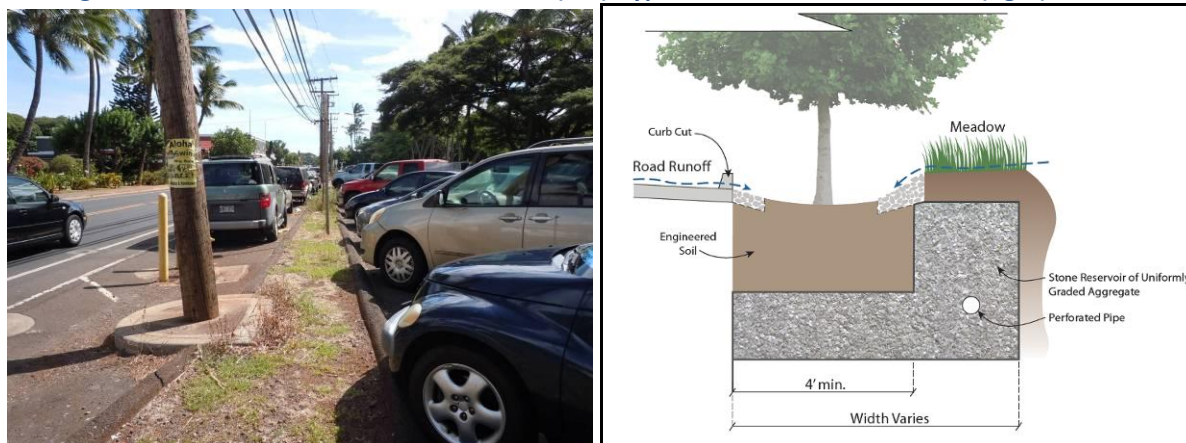
Existing island to be retrofitted into a tree trench (left); typical tree trench cross section (right).

The retrofit design utilizes the existing 4-ft “island” between the HBP Parking Lot and Lower Honoapiilani Rd. The edge of this island is the low point in the drainage area with catch basins capturing runoff from both the road and parking lot and conveying it into the 7’x1.5’ box culvert (HBP-1). The concept is to remove this island, and the small no-parking areas along the road, and replace them with a long “tree trench” sized for the 1-inch rain event. Overflows from the trench would flow back into the existing storm drains via new overflow structures. The existing catch basins would be either removed or covered and left in place. The trench would be planted with low-growing, low-maintenance native plants to preserve the ocean view and protect the utilities (e.g., overhead wires, etc.).

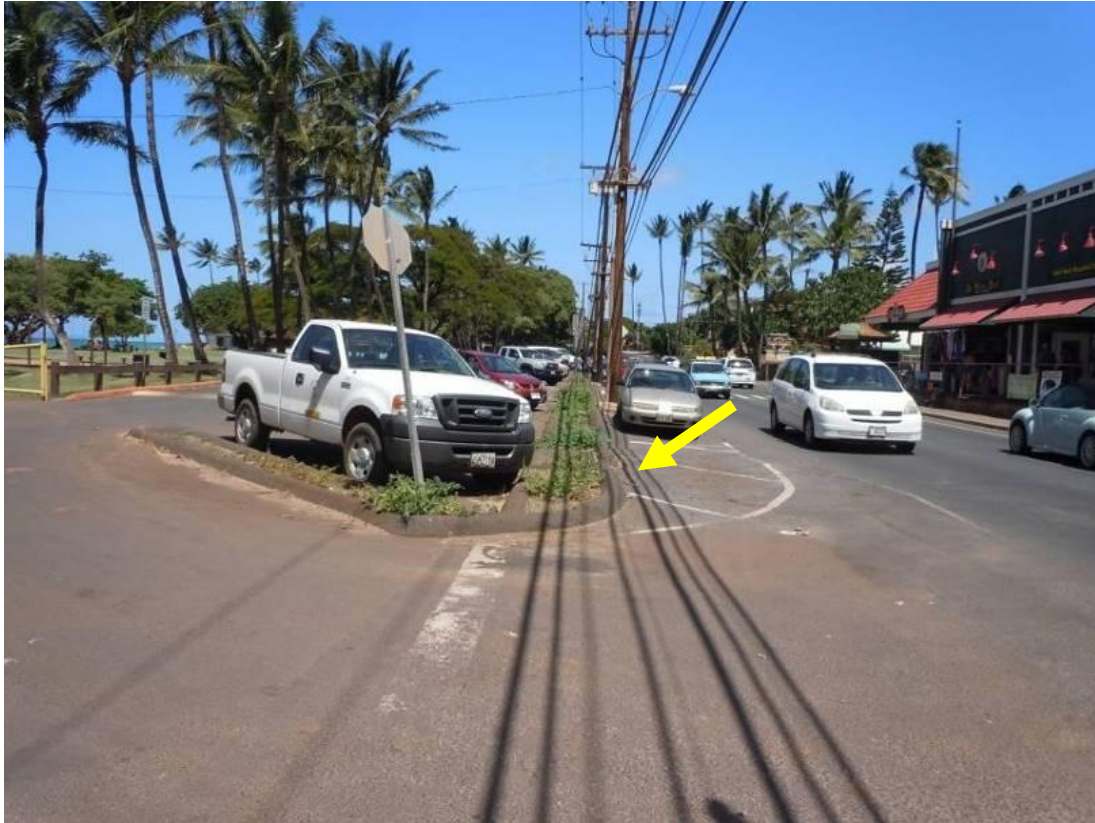
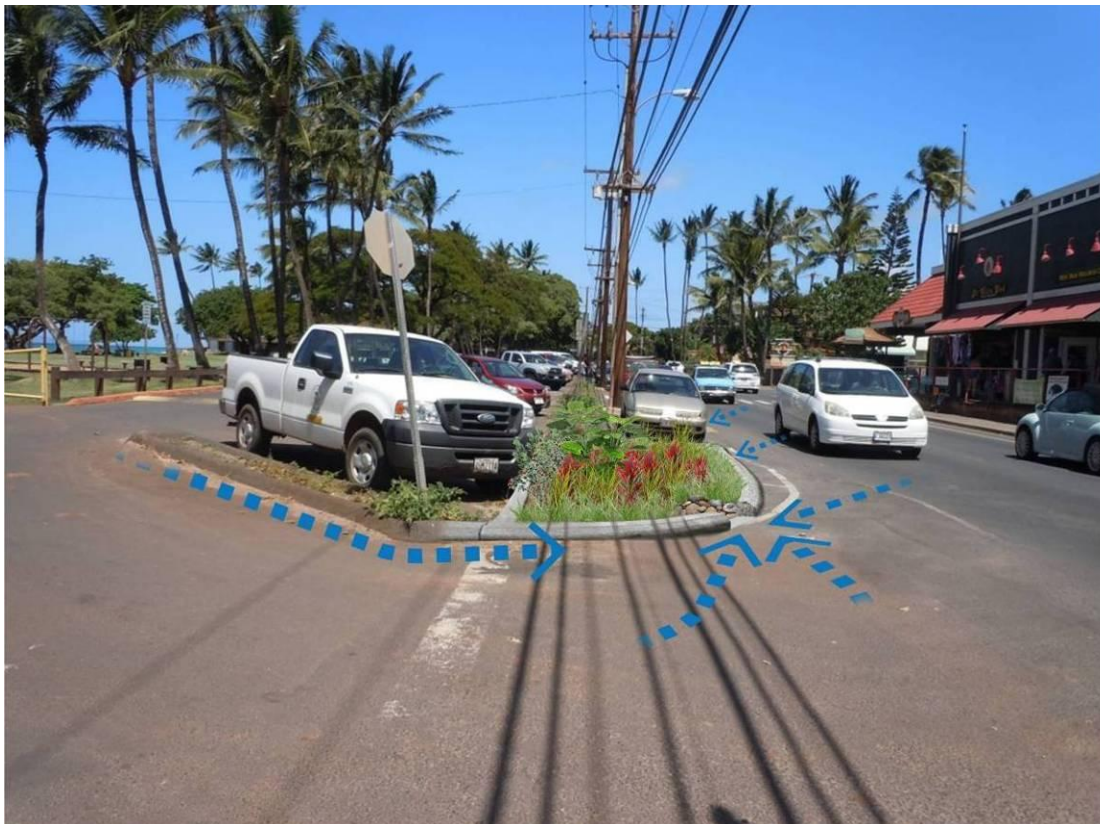
Looking north at the existing island between HBP and Lower Honoapiilani Rd, with the existing catch basin identified with the yellow arrow (top). Graphic rendering of tree trench and flow paths (bottom).

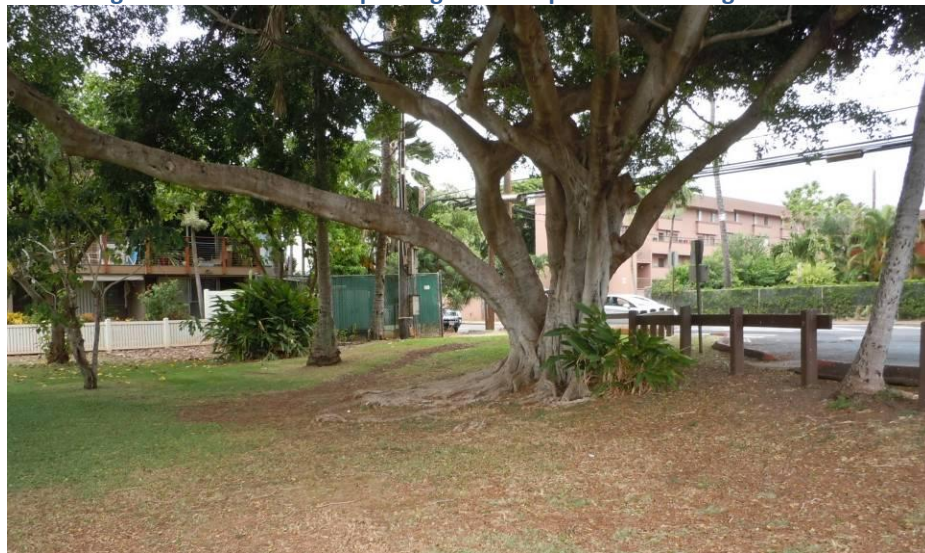
Tree along the north end of the parking lot to be protected during construction.

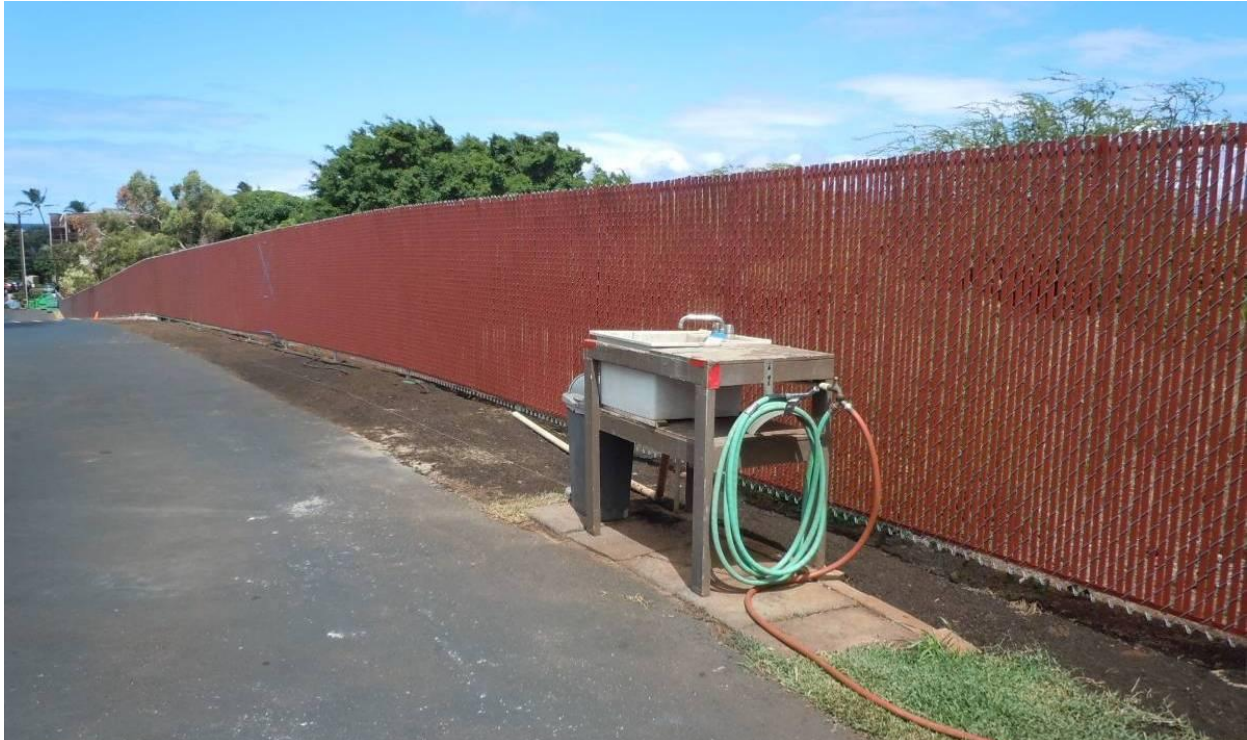
This utility sink next to the laundry building at Hale Royale discharges on exposed soil and then down the steep driveway to a catch basin at the intersection with Lower Honoapiilani Hwy.

- Wash water—Wash water should be properly disposed of rather than allowed to enter the storm drain system. Dirty mop buckets contain gray water and should be dumped into a sink connected to the sanitary sewer. Car wash areas should not discharge to the storm drain system without some form of advanced treatment or they should be connected to the sanitary sewer system.

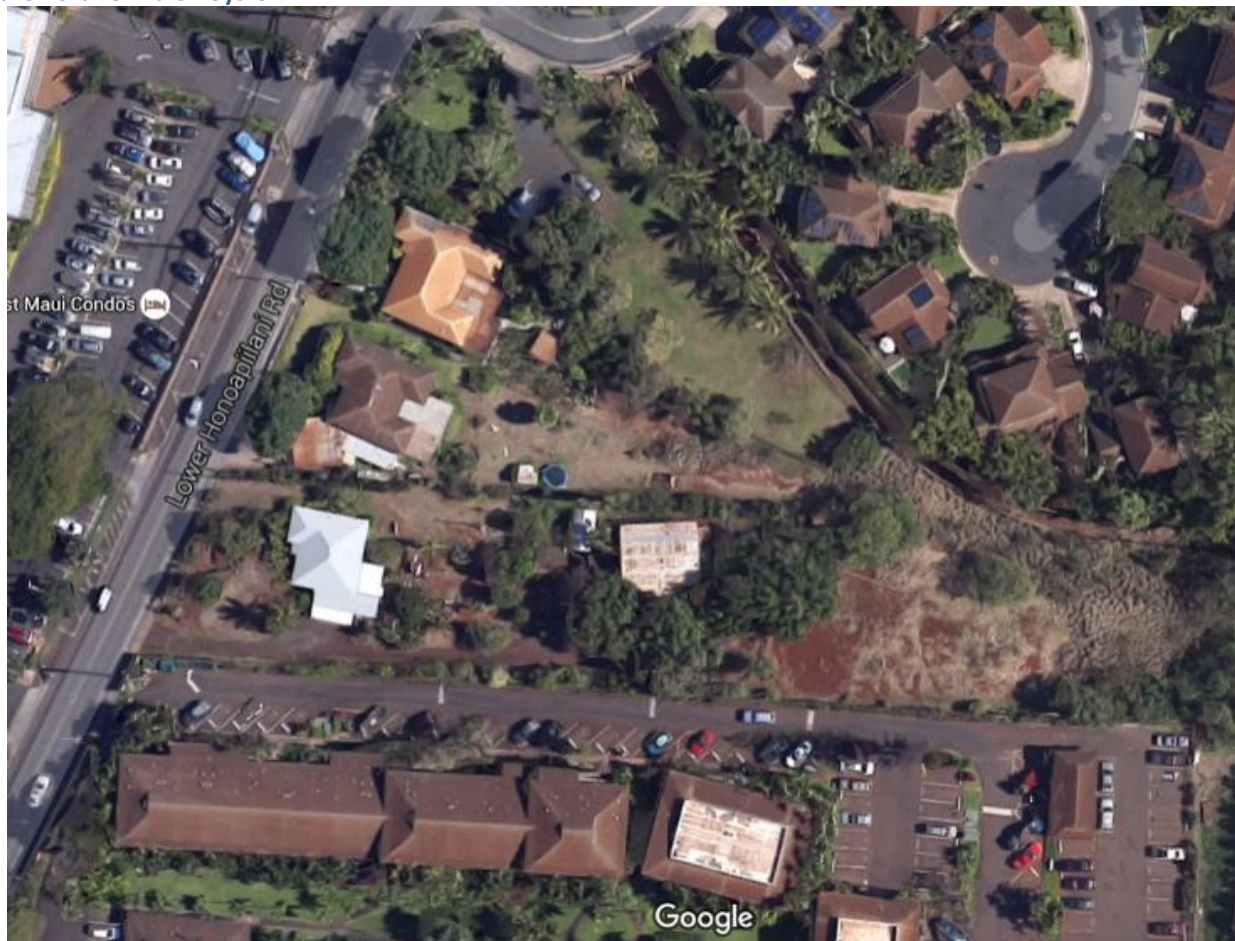
The aerial from Google Earth shows the extensive areas of exposed soil in the single-family residential area to the north of Hale Royale.

- Soil Stabilization — When bare soil is exposed to rainfall, the soil will erode and lead to sedimentation of downgradient stormwater structures and eventually streams and coral reefs. Bare areas should be stabilized as soon as possible with vegetation or rock to prevent sedimentation.

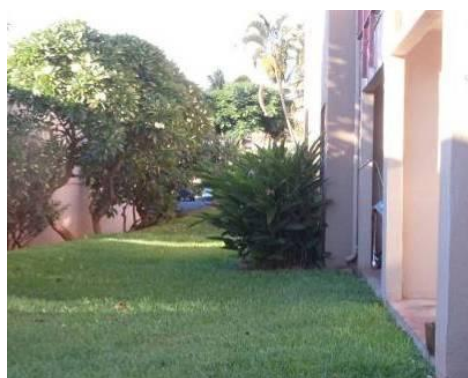
This grassy area next to a downspout provides and excellent opportunity for a rain garden at Sunset Terrace.

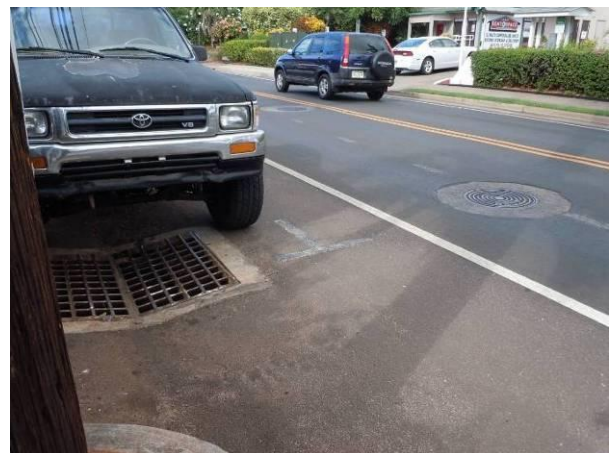
Catch basins along Lower Honoapiilani should be stenciled to let people know that they discharge into the ocean.

Maui County DPW: The drainage system on Lower Honoapiilani Rd is the major stormwater infrastructure in this watershed. DPW is responsible for maintenance of this system as well as the HBP Channel itself. DPW workers should be educated on stormwater issues as they relate to coral reefs. In addition, DPW could consider installing storm drain markers and/or hosting a volunteer work day to do storm drain stenciling for both DPW-owned catch basins and curb inlets as well as private structures that connect to the DPW system.
